### Certificate of Conformance for Freight Container Mechanical Seal Testing Seal Classification: Indicative seal

TEST REPORT NO.: M1124128-T01

SUBJECT: Freight containers Mechanical seals classification Testing

Name of Article: FORT MEGA POST SEAL

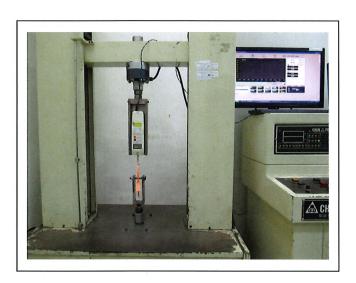
### Universal Testing Machine

Testing Instrument: Universal Testing Machine (No.TG0103)

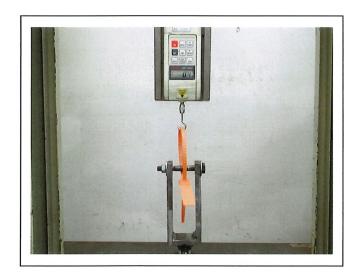
Tensile Set up

The seal was gripped in a tensile machine and a pull force applied.

Specimen No.	Requirement Load to failure	Result kN	Seal classification
A000001M	10.0 kN: High security seal	0.36	Indicative seal (I)
A000002M	2.27 kN: Security seal	0.37	Indicative seal (I)
A000003M	< 2.27 kN : Indicative seal	0.35	Indicative seal (I)
A000004M		0.39	Indicative seal (I)
A000005M		0.36	Indicative seal (I)

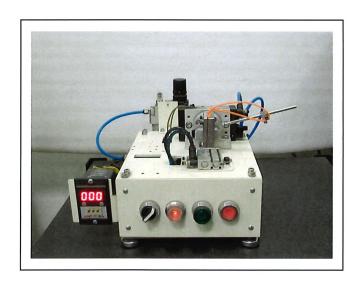
Bend Set up

Fix the locking end and flex the material adjacent to this fixed end repeatedly through an arc of 180° until failure

Specimen No.	Requirement Cycles to failure	Result Cycles	Seal classification
A000011M	501: High security seal	< 251	Indicative seal (I)
A000012M	251: Security seal	< 251	Indicative seal (I)
A000013M	<251: Indicative seal	< 251	Indicative seal (I)
A000014M		< 251	Indicative seal (I)
A000015M		< 251	Indicative seal (I)
